The Spodsbjerg Drej wreck

and the origins of “klamp” shipbuilding in Denmark

IDA HOVMAND and OTTO ULDUM

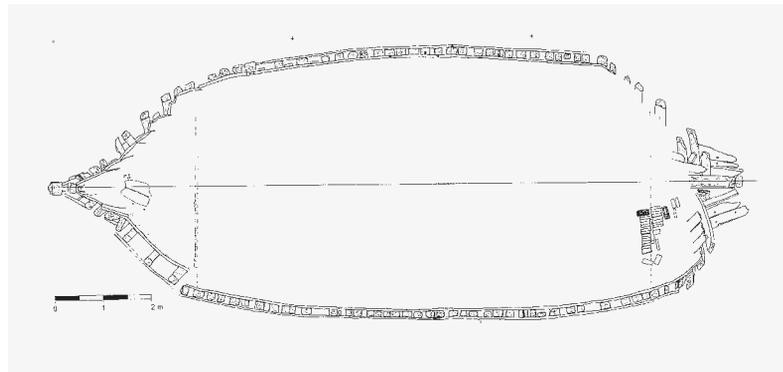
Fig. 2: The site plan recorded during the 1997-season. The uneven framing is clearly visible. In the central part of the hull, between the two bulkheads the hold was filled with roof tiles.

A very traditional approach was taken, and at regular intervals a nail was put into some of the frames and tagged with a number. The circumference of the preserved top level of the frames was then measured by triangulation, and the details of the individual frames and the planking were later added to the site plan from 1:20 drawings made under water (fig. 2). In addition to the site plan, a number of sketches were made of the side view in the stern area, but unfortunately time did not permit the measuring of any sections. The cargo of roof tiles was left *in situ*, and as a consequence the remaining accessible areas were in the stem and stern. These triangular spaces were excavated with the aid of water dredges, and the contents of the nets were sorted at the end of each day, once the team was well ashore.

As the aim of the field course was twofold, on the one hand to perform an archaeological investigation, and on the other to train inexperienced divers, the six-day season of 1997 must be labelled a success. A general site plan was obtained, and the excavation of the stem and stern areas yielded a number of objects that would prove valuable in the analysis of the find. Furthermore a ship had been the object of a field course in maritime archaeology, giving students and enthusiasts a rare opportunity to cut their teeth on an actual historic wreck.

So far the construction of the ship itself has briefly been labelled "flush planking", but it is possible to describe the technology behind it further. Flush planking is not synonymous with the term "carvel", which should be applied to ships with built-up pre-erected frames. Using the planking as the primary - and initial - hull feature can also arrive upon flush planking, as the research in Dutch bottom-based tradition has shown (HOCKER 1991, MAARLEVELD 1991, 1992). The Spodsbjerg Drej wreck show features similar to those of this technology. The fragment that was raised in 2004 showed no sign of the individual frame timbers being fastened to each other, and the preserved top ends of the framing can be seen on the site plan as very unevenly spaced. This would not have

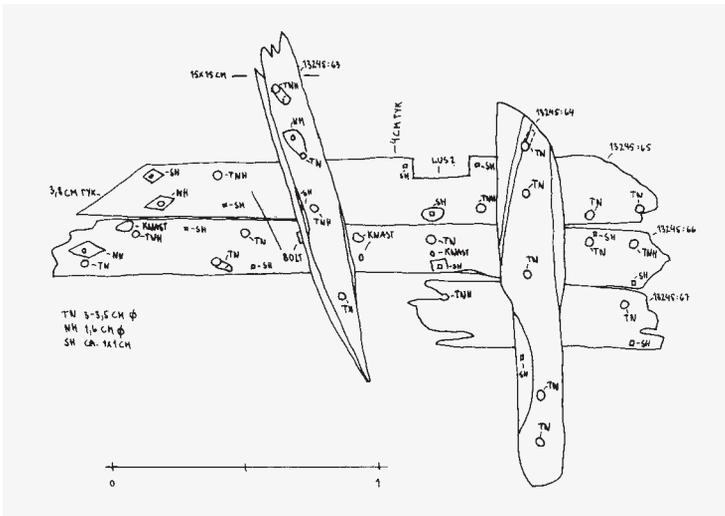
Fig. 3: The fragment of the wreck raised in 2004. The oblique scarf is not likely to be a hood end, since no nails holes can be seen.

Finding the wreck proved difficult. The spot itself was easily found with the aid of bearings, but despite intensive criss-cross swimming in the very clear water, no sign of the wreck presented itself. The sand bank had covered the ship once more. The search area was extended slightly, and the efforts were rewarded with the find of a fragment of the wreck. This consisted of three pieces of planking, and two pieces of frame timbers (fig. 3). The distance from the fragment to where the wreck was expected to be found, was only about 50 metres. With some effort the hull fragment was raised from the seabed onto the dive boat, and brought ashore for documentation. Finding this "sample" of the ship also meant, that one of the goals of the investigation could be fulfilled, as the timbers would be well suited for dendrochronological analysis.

The samples collected were analysed by Aoife Daly (dendro.dk), and showed the last ring in the sequence to be grown in 1759 AD. The felling of the trees is believed to have taken place after 1775. The sequence was compared with

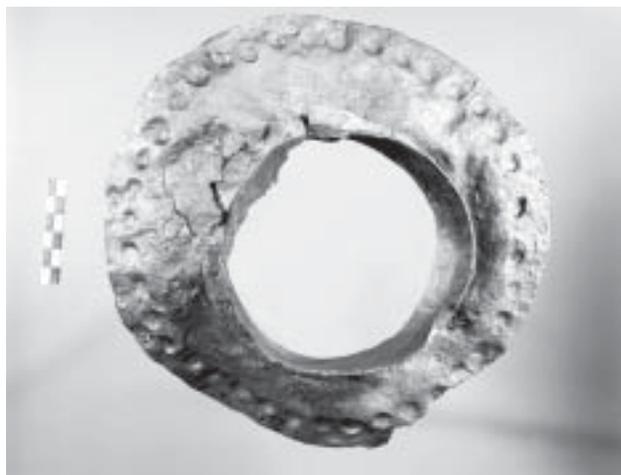
Fig. 4: The iron fitting believed to be a flange for letting a chimney pass through the deck.

One of the larger objects found was a circular iron flange, which is believed to be a fitting from where a chimney went through the deck (fig. 4). This was however found in the stern cabin, so either there was a stove for heating here, or the chimney fitting shifted aft when the deck collapsed. Other finds from the forecastle indicating a galley are a wooden spoon and several sherds of pottery. That the after cabin might have been a little more comfortable and nicely furnished is suggested by the finds of a moulded board presumably from a closet and a decorated peg. In this area fragments of two glass bottles and some porcelain also came to light. The cabin most likely had a window in the transom, as fragments of windowpanes and putty were found here. Pipe smoking must have been quite popular judging by the copper alloy mounting to a pipe lid which was found in the forecastle, and fragments of clay pipes found in both ends of the ship. One should probably not expect a very big difference in levels of luxury between the aft cabin and the forecastle, or a corresponding wide gap in prestige from the skipper to his one or two sailors.

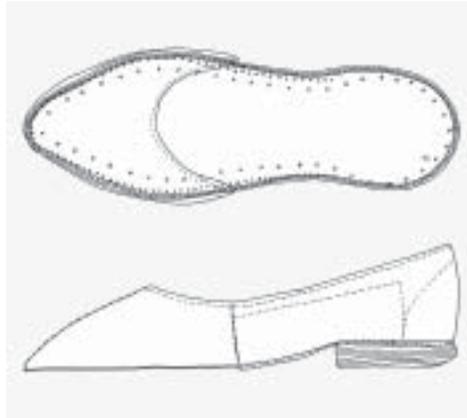
Fig. 5: The "pump" shoe that is almost entirely preserved.

The one complete shoe found on the wreck is very light in construction and fits the description of the kind of shoes known as "pumps" (fig. 5). This type of footwear was supposedly often used for going ashore during the 18th and 19th century (HENNINGSEN 1979). The shoe in question is made of very soft calf skin leather and all the parts which make up the upper are separately lined with the same material. The upper part of the shoe consists of a vamp, two sides and a heel cap. The grain side of the leather is outward on all these parts, but positioned towards the foot on the parts used for lining the shoe. The bottom of the shoe consists of an inner, middle and outer sole to which a heel was attached, the heel consisting of 7 layers of lea-

ther. The outer sole is very worn, and the upper half is missing. In this case, thin wooden slitters were also placed between the outer and middle sole. The heel differs from the other shoe fragments with heels, as this heel is not only held in place by wooden pegs, but 4 iron nails were also used. (These have badly deteriorated, but can be seen as black stains on the leather surface). The thread is still preserved in some of the stitch holes. The shoes might tell us something about the fashion of the time, the financial status of the wearer, as well as about the size of the wearer and as mentioned earlier how that person walked. The "pump" is altogether very different in feel and quality to the fragments of the other shoes that were made of stiffer heavier leather and repaired at least once which the "pump" is not. It seems much more likely that the shoes were worn on special occasions, like going ashore. The presence of this type of shoe also shows that at least one of the crew had the financial means to be able to purchase items of fashion, and an interest in doing so. It has been possible to estimate the size of the fragmented pair of shoes, in order to compare them to the "pumps". The "pumps" are at least a couple of sizes smaller than the others, and it therefore stands to reason that the pairs did not belong to the same person.

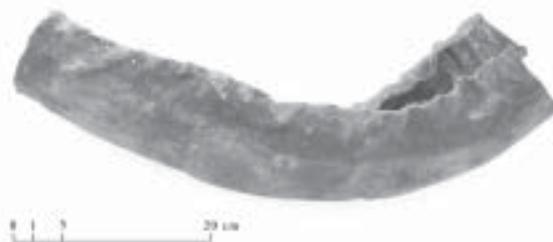
Fig. 6: The leather sleeve, the signs of wear show that it is from the left side of the jacket. To the left is the decorative tooling near the cuff. The lacing holes are clearly visible.

A rather unusual leather object is a sleeve for a jacket or such like (fig. 6). It consists of a rectangular piece of leather (ca. 58 x 19 cm) made from quite thick cattle skin (4 mm after conservation). It has maintained its shape during conservation, which is that of a slightly bent arm. It has holes along both the long sides (16 on one side, 19 on the other), and there are still fragments of a vegetable based thread in some

of the holes, which shows that the two sides had been laced together. When worn, the lacing would have faced inwards towards the body. Tooling can be seen on the end of the sleeve near the hand. A couple of centimetres above the tooling, two holes 1 cm apart can be seen. The function of these is not clear, but they might have been used to thread through a lace or string, in order to tie the sleeve tightly around the arm. On the other, short side, there are 4 holes of different sizes, approx. 5 cm from what would have been the edge, however the piece along the edge is missing. These holes could have been used to secure the sleeve to a bodice. The signs of wear on the sleeve show that the area corresponding to the elbow is most heavily worn which is as one would expect. The thickness of the leather, the design and the wear on the sleeve, suggest that it was part of a garment which first and foremost served a functional purpose.
